# Return to Flight Status

# Columbia Investigation

# Columbia Investigation Overview

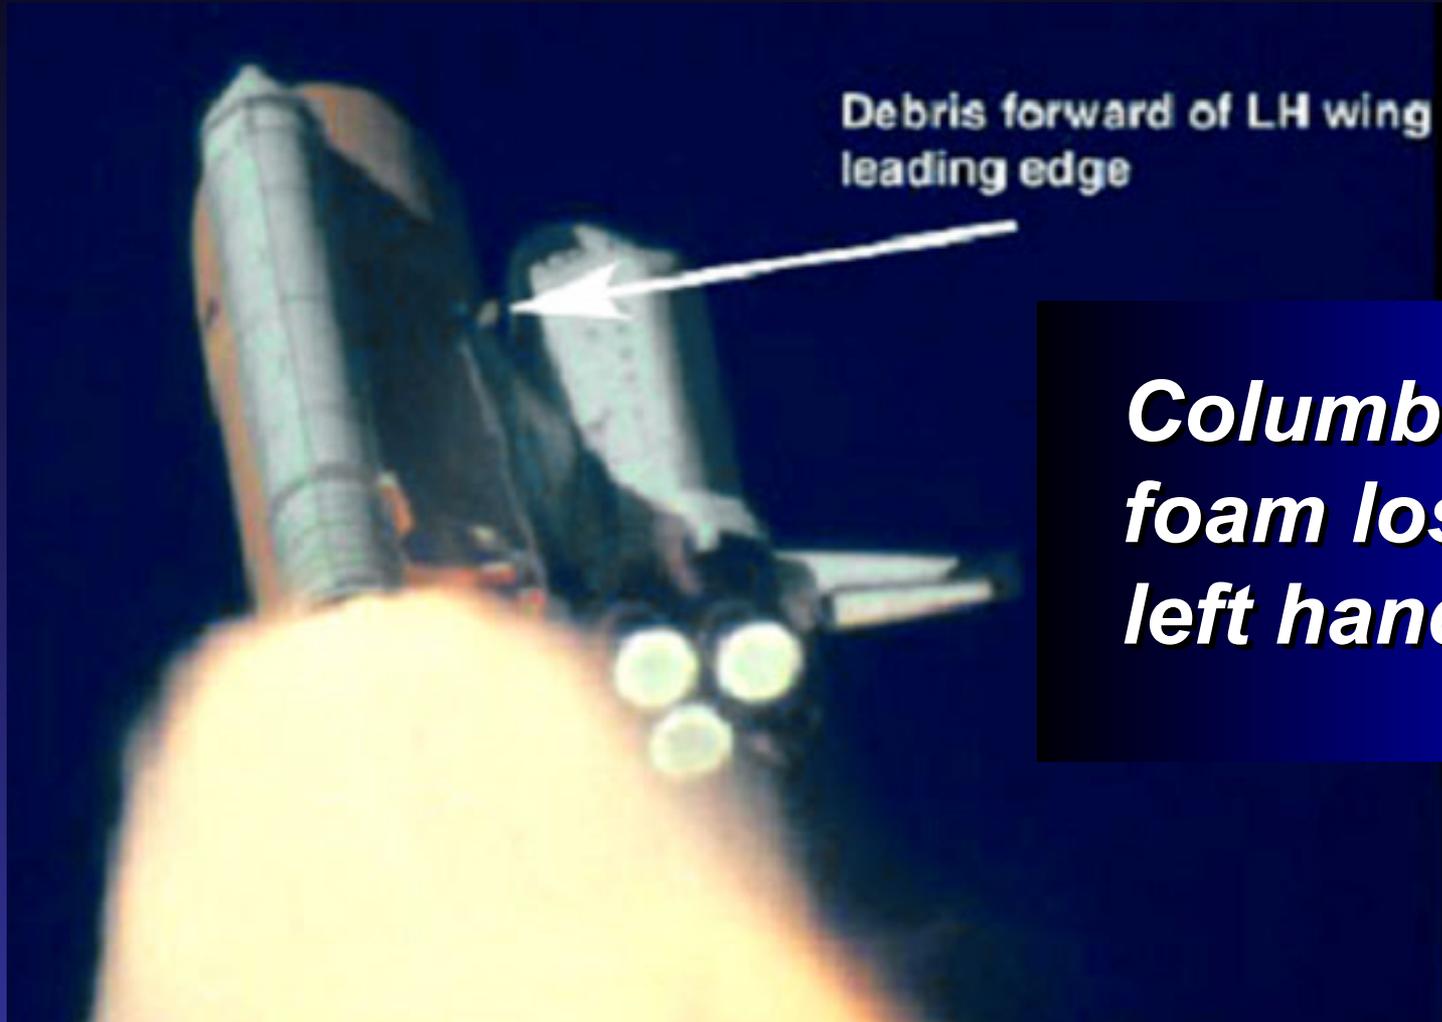
***Columbia hit by  
foam lost from  
left hand bipod***

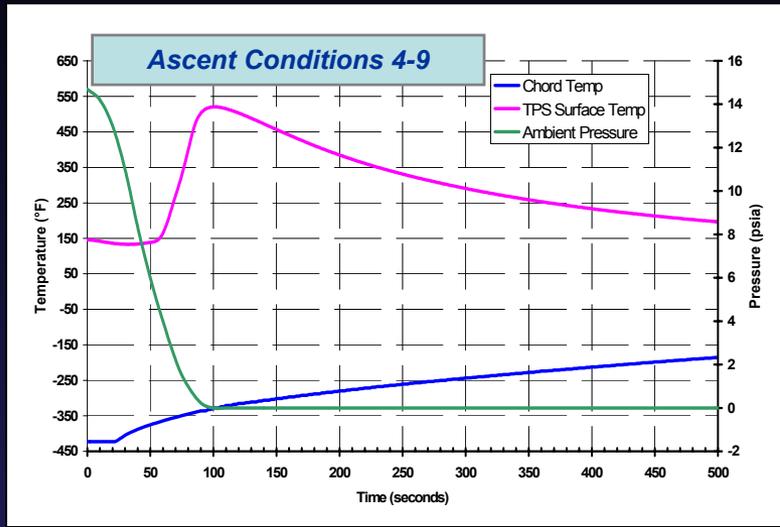
1. LN2 begins to form in voids as LH2 level approaches flange
2. Flange temps rapidly fall to form SN2 in leak paths blocking flow
3. LN2 and SN2 begins to accumulate in Y joint during hold
4. During ascent LH2 level drops, flange temps begin to rise
5. LN2 begins to gasify causing foam to crack
6. Ascent heating weakens outer layer of foam
7. LN2 enters crack and begins rapid gasification
8. Crack rapidly propagates to substrate, conathane, flange
9. Divot produced due to weak outer layer and LN2/GN2

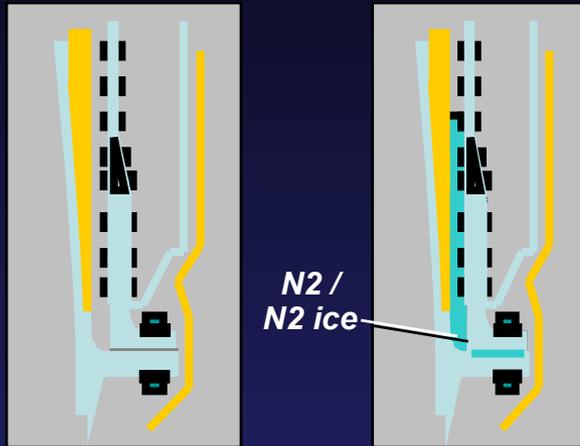
Intertank "Y-joint"  
(Warm)

Intertank "Y-joint"  
(Cryo)

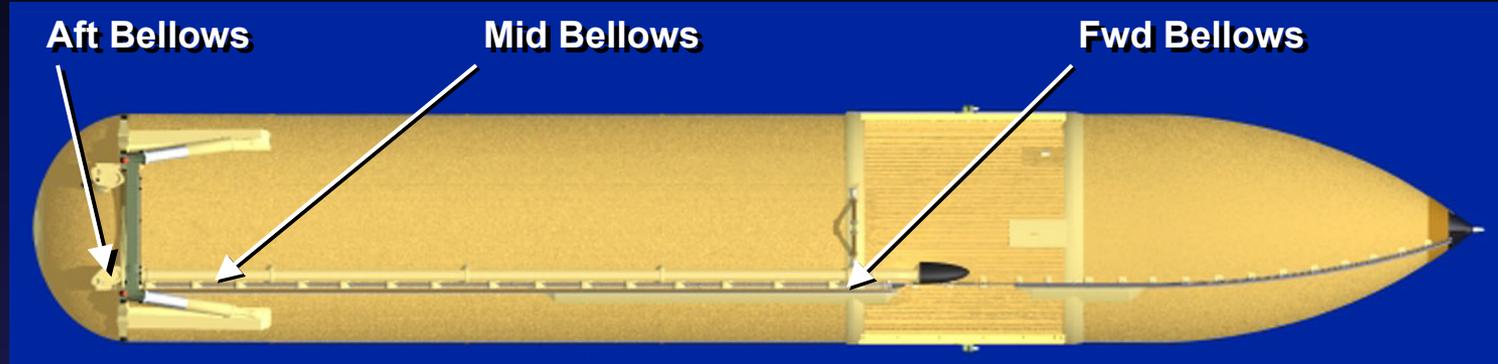
***An additional debris source was identified for elimination***

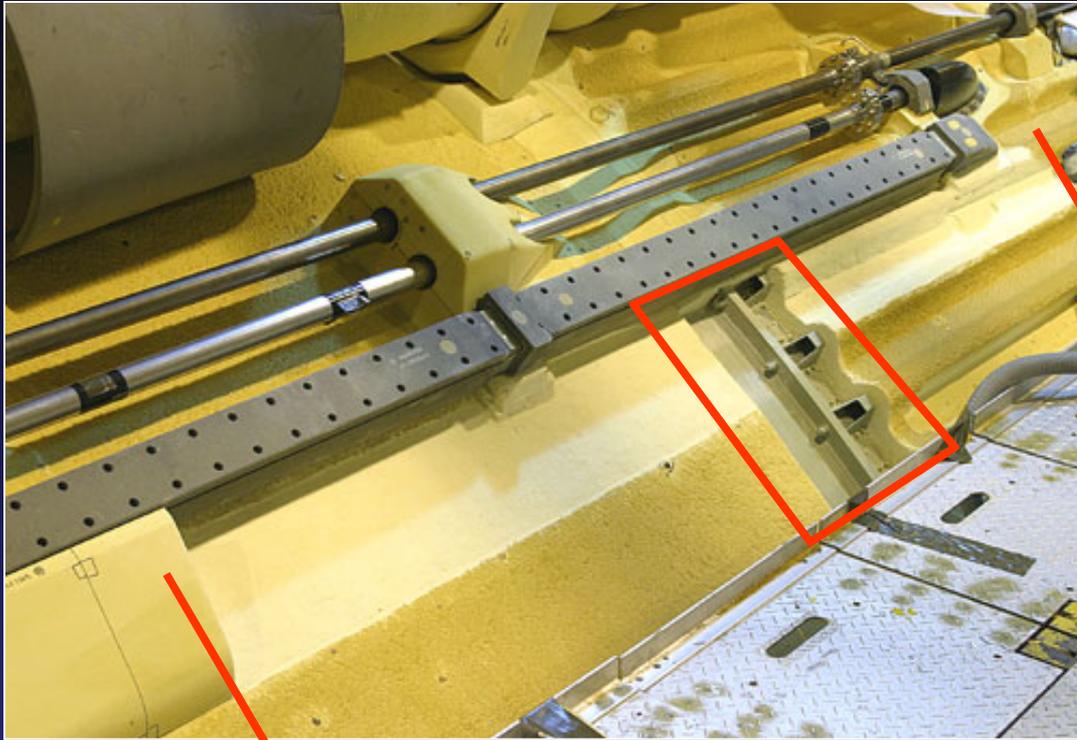
Ten Foot Section of Removed PAL Ramp  
with Critical Area Shown in Red Box

***We have removed the PAL ramp over the flange and  
are refining the process to replace it***
